# Portage Creek Sediment Remediation Project Kalamazoo, Michigan

Post-Sediment Removal Structure Feature Assessment  
Removal Areas SA5-Axtell, SA5-D and SA5-C

F&V Project Number: 809930  
October, 2012

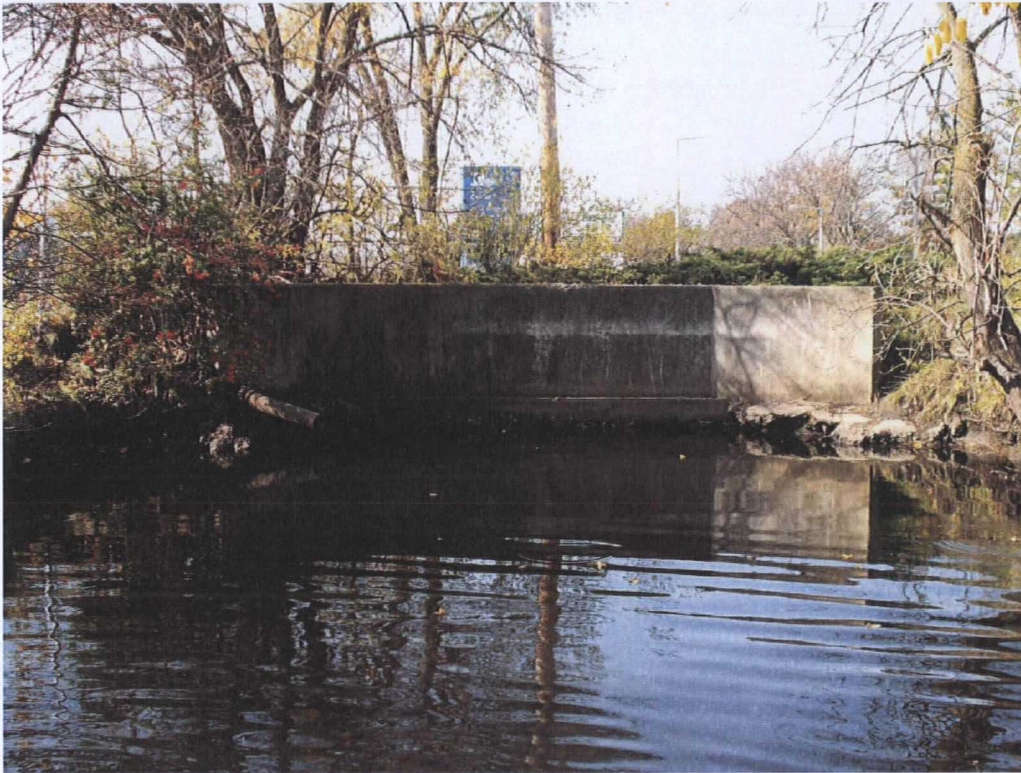
- The structure does not appear to have been impacted during sediment removal.

Elevation view of the structure

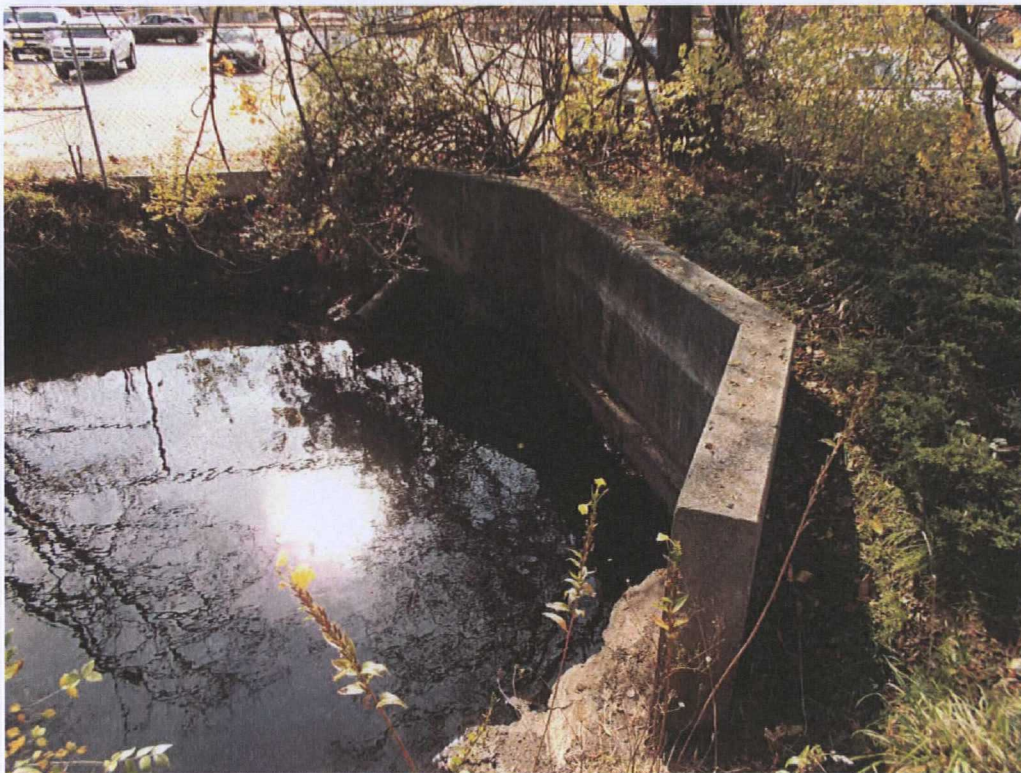
Structure viewed from the north bank

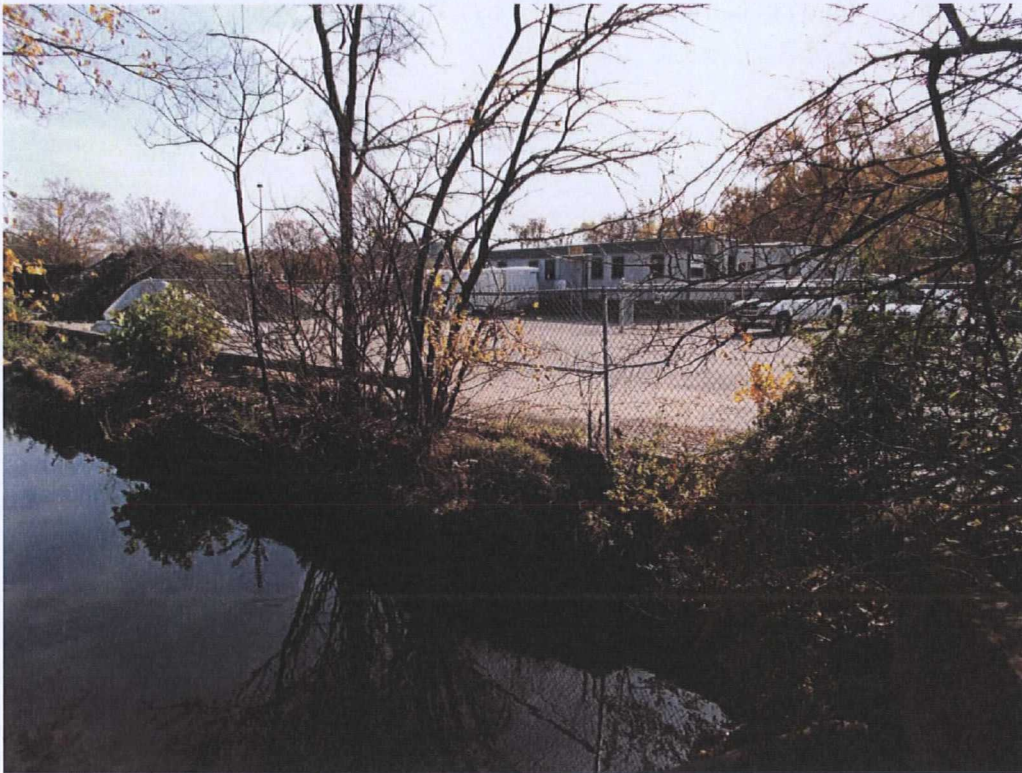
- The west end of the fence was not removed and does not appear to have been impacted during sediment removal.
- The fencing removed to accommodate sediment removal should be replaced, if directed so by the property owner.

View of remaining fence from the northwest

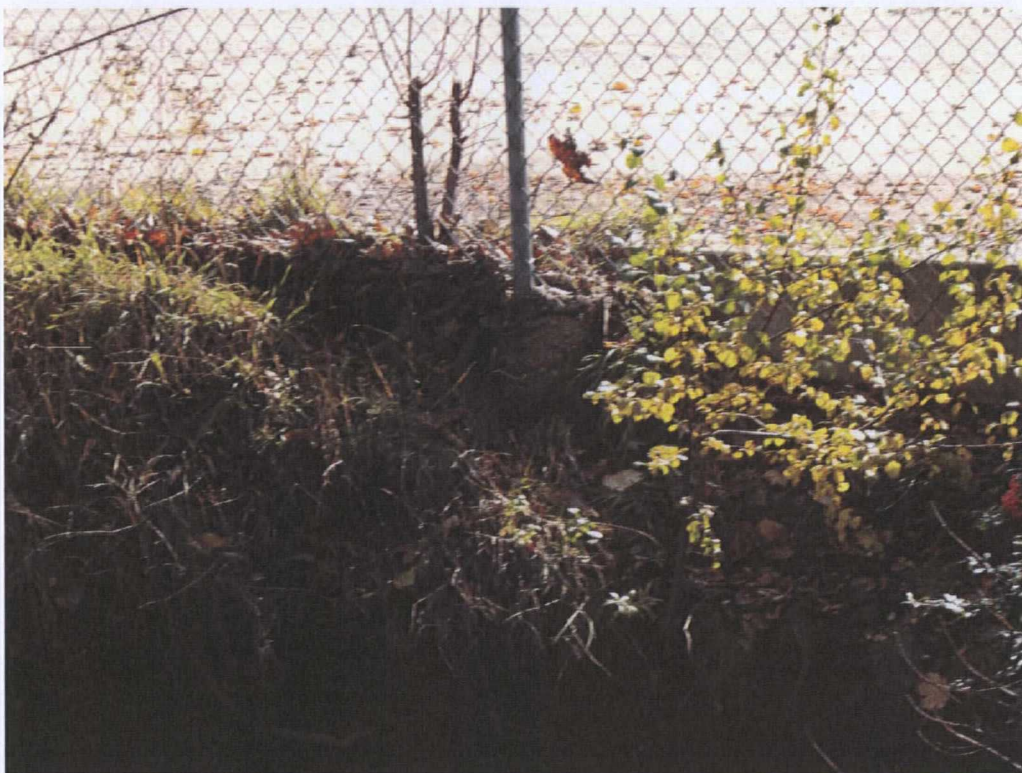
Concrete base exposed by bank erosion

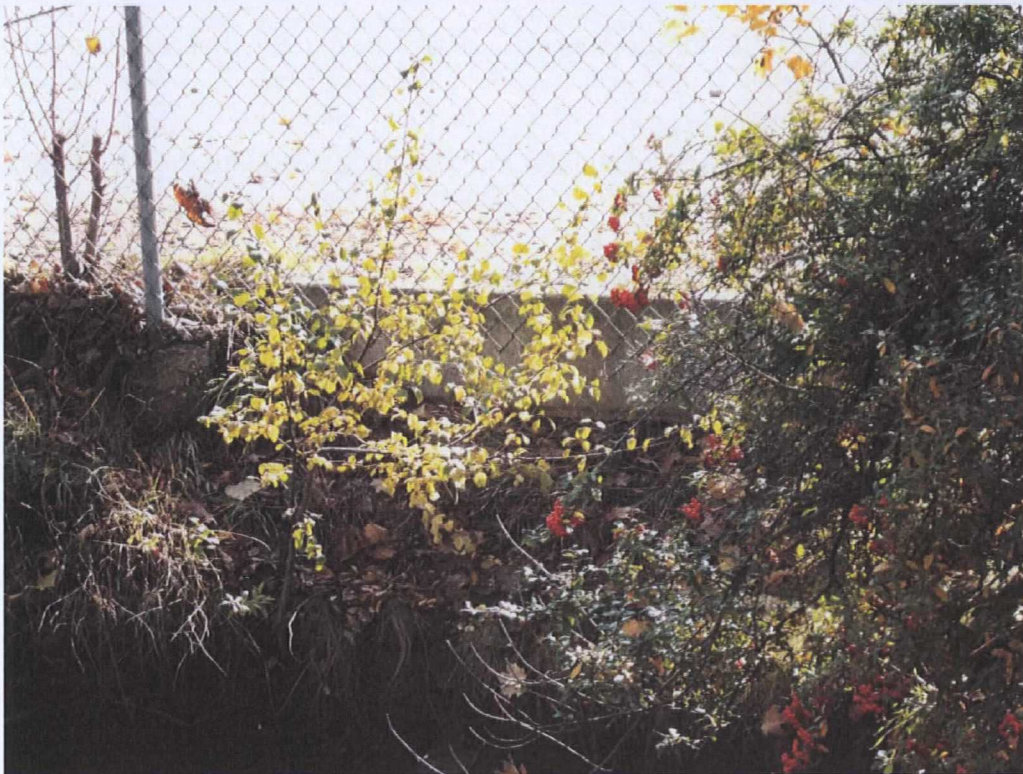
- Bank erosion along the back of curb appears unchanged.
- The structure does not appear to have been impacted during sediment removal.

Bank erosion exposing back of curb and vegetation growth

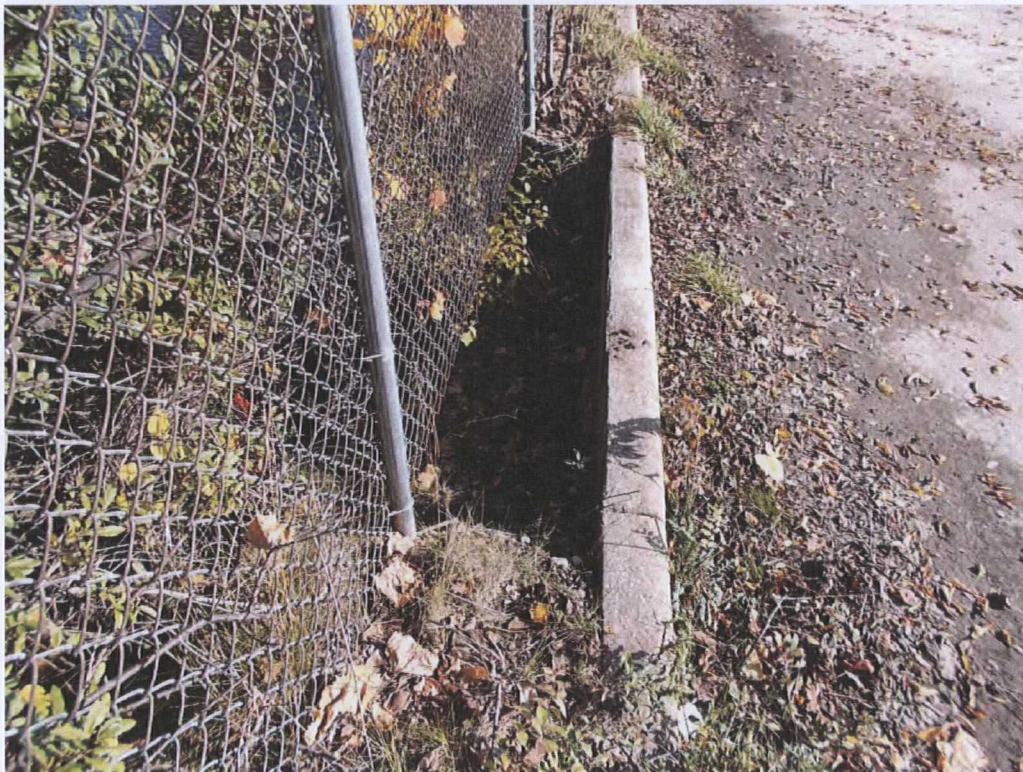
View of bank erosion behind the concrete curb

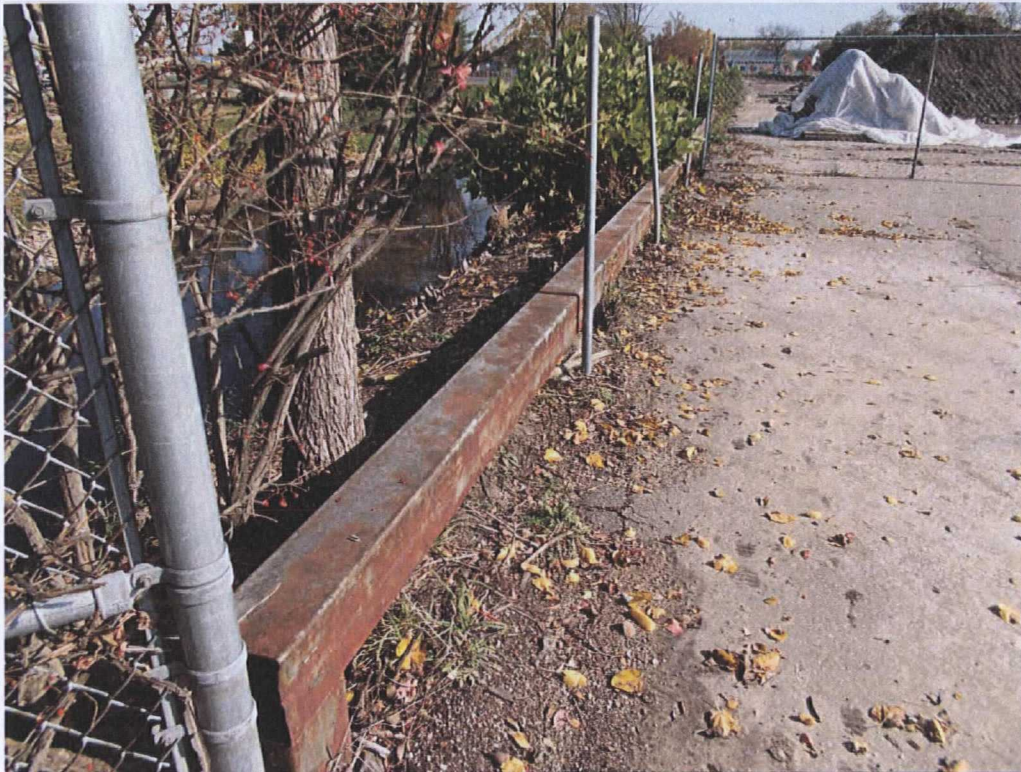
- There are still several failed section of railing.
- The structure does not appear to have been impacted during sediment removal.

West end of rail looking east

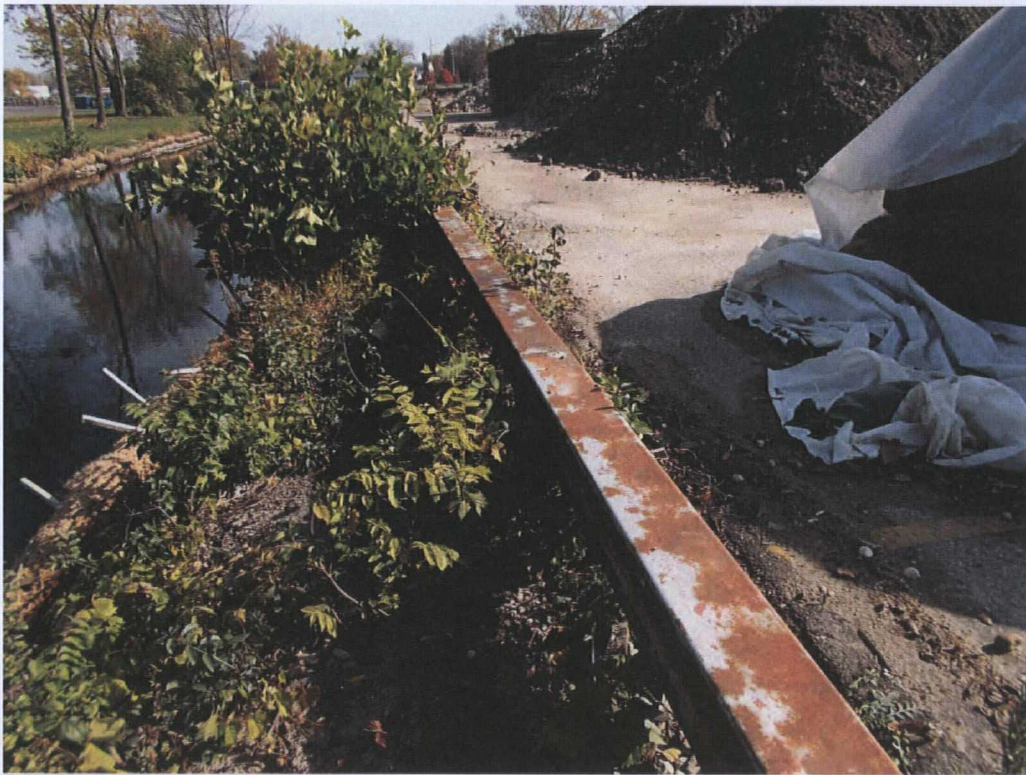
Corrosion on rail looking east

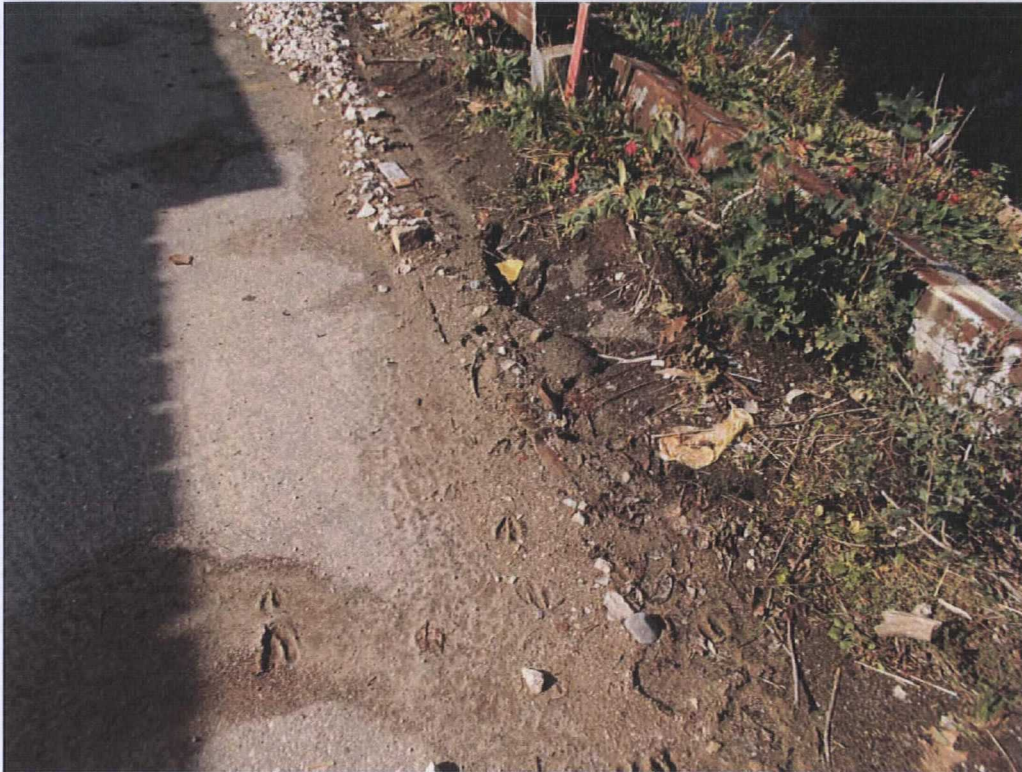
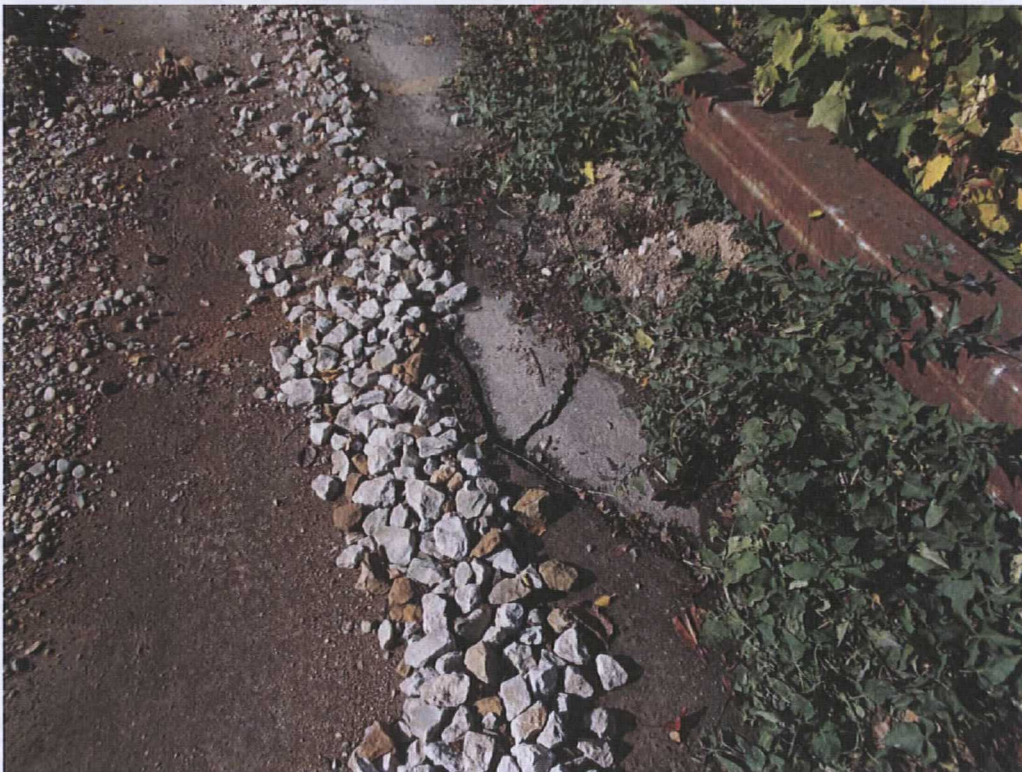
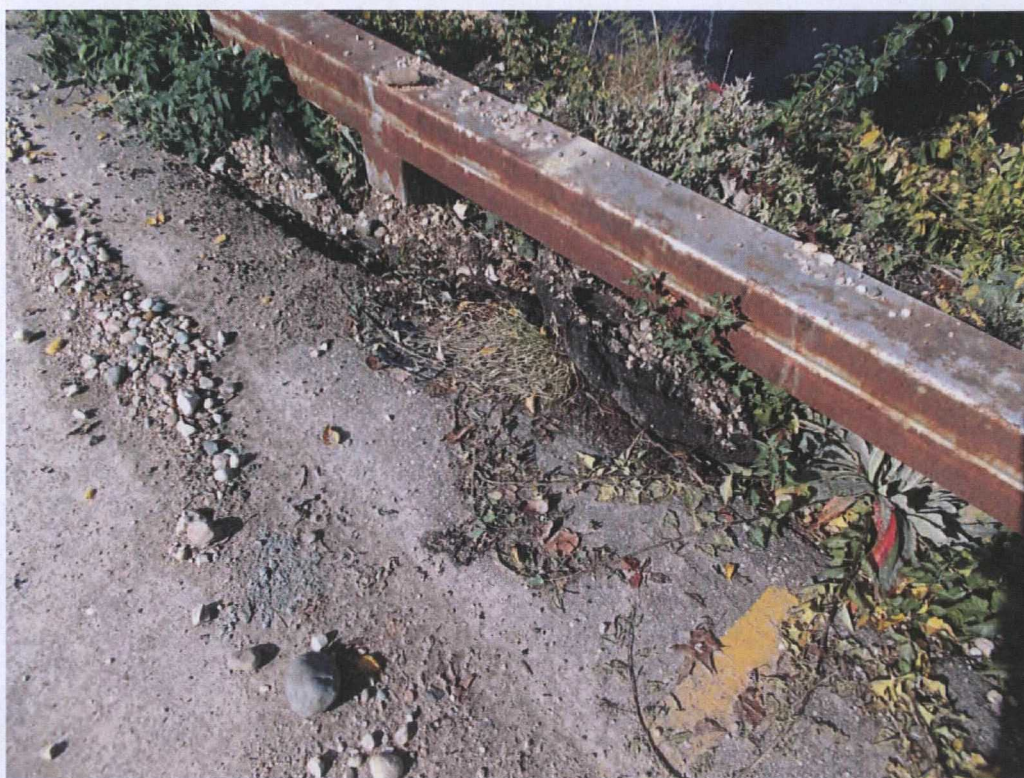
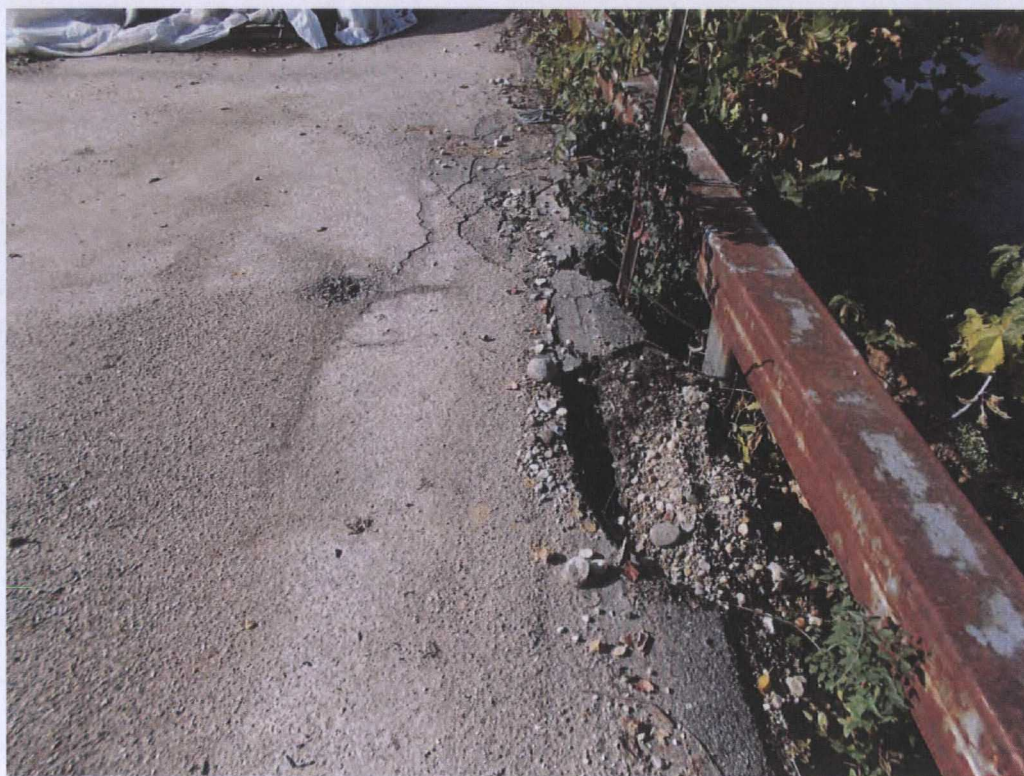
- The asphalt had significant cracking and minor spalling prior to sediment removal operations, however, cracks appear to have expanded and the edge of the asphalt pavement has significant spalling in several areas.
- Spalled areas should be patched if required by the property owner.

Cracking and edge spalling on asphalt pavement

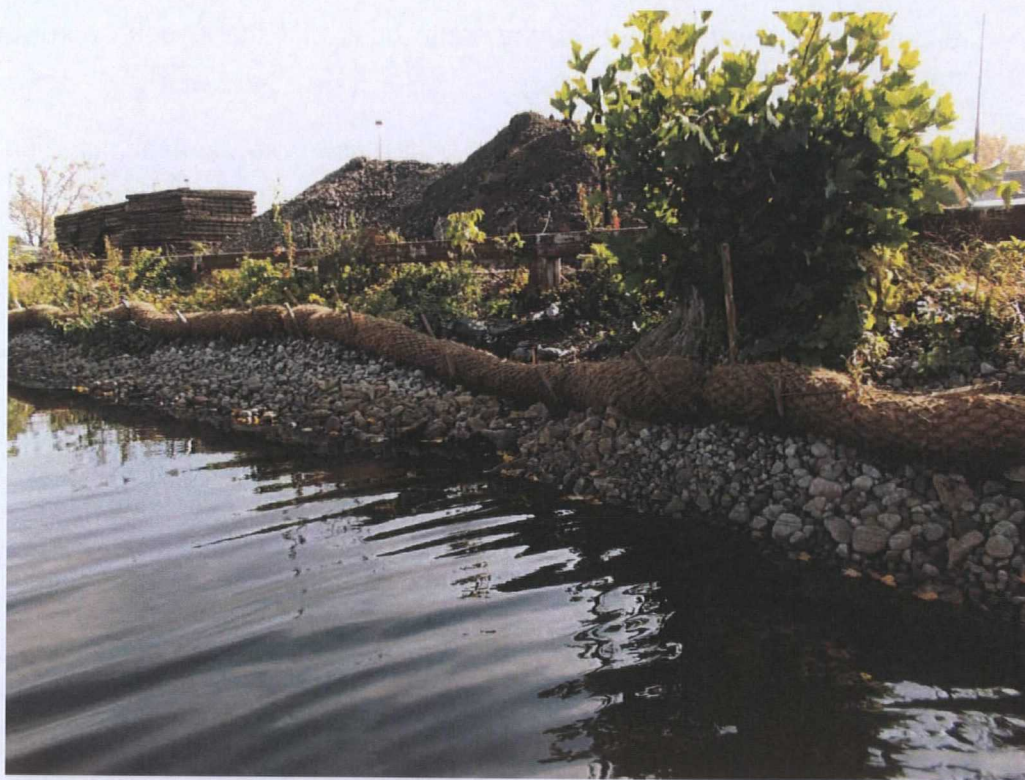
- The spillway was removed in conjunction with sediment removal, exposing a concrete outlet at the water line. The concrete outlet does not appear to have been impacted during sediment removal.

View of exposed outlet from upstream channel

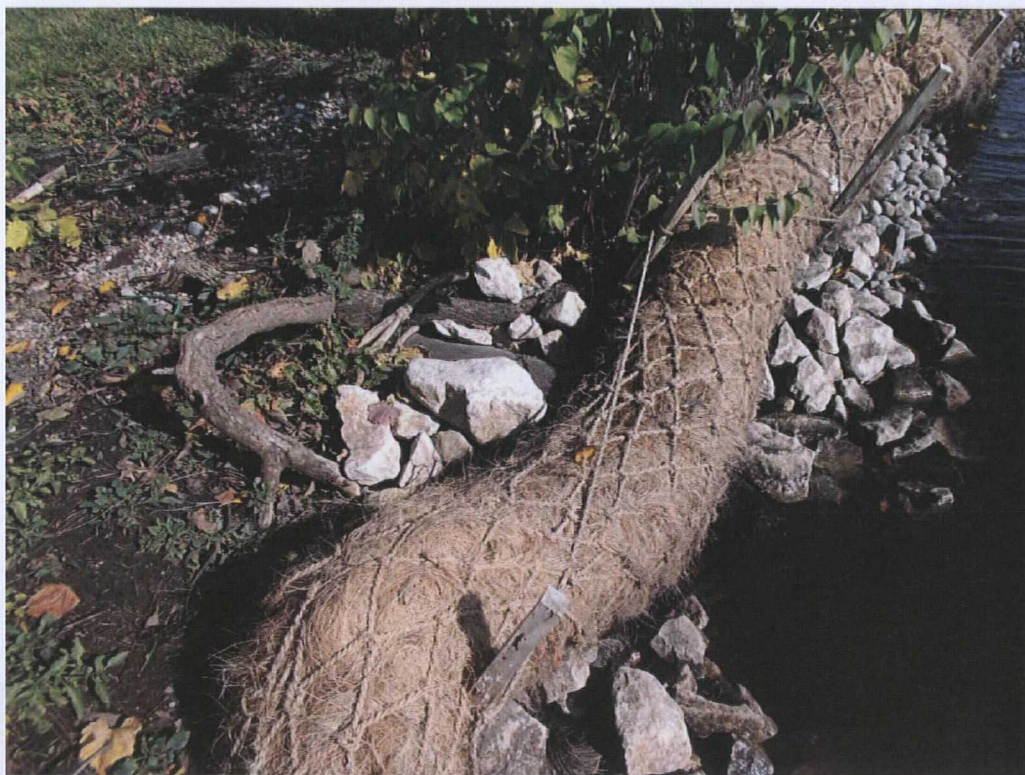
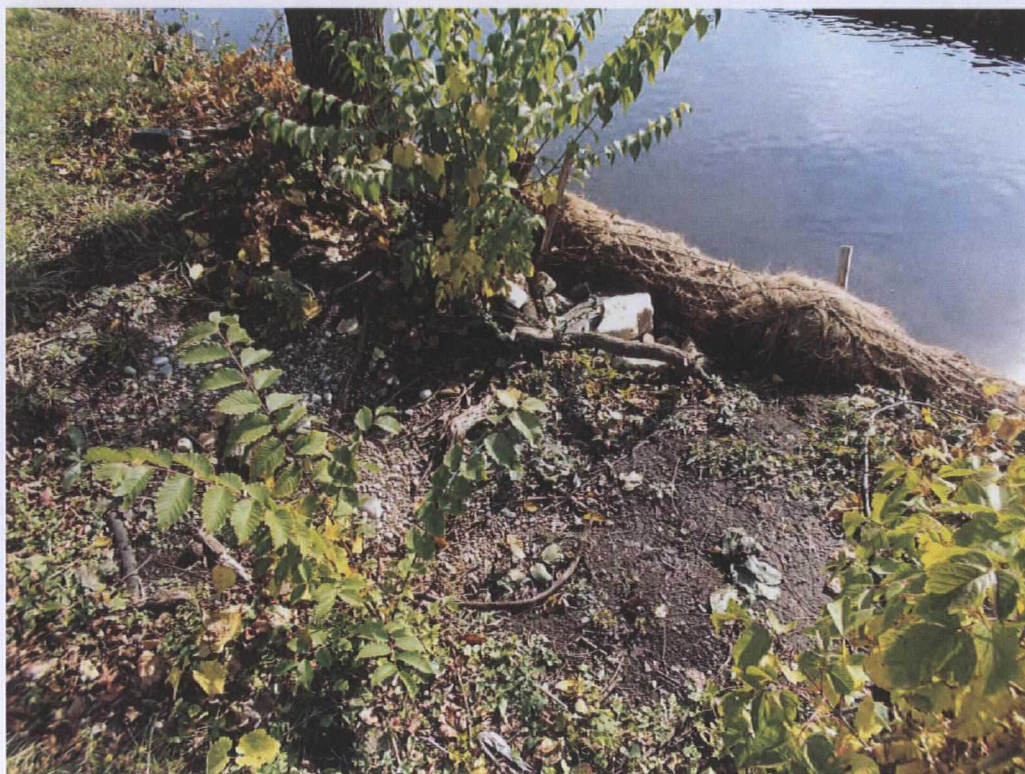
- Failed end sections were removed in conjunction with sediment removal.
- The remaining structure does not appear to have been impacted during sediment removal.
- The core log has been installed over the outlet and should be adjusted to prevent blockage.

View of the structure from the upstream bank

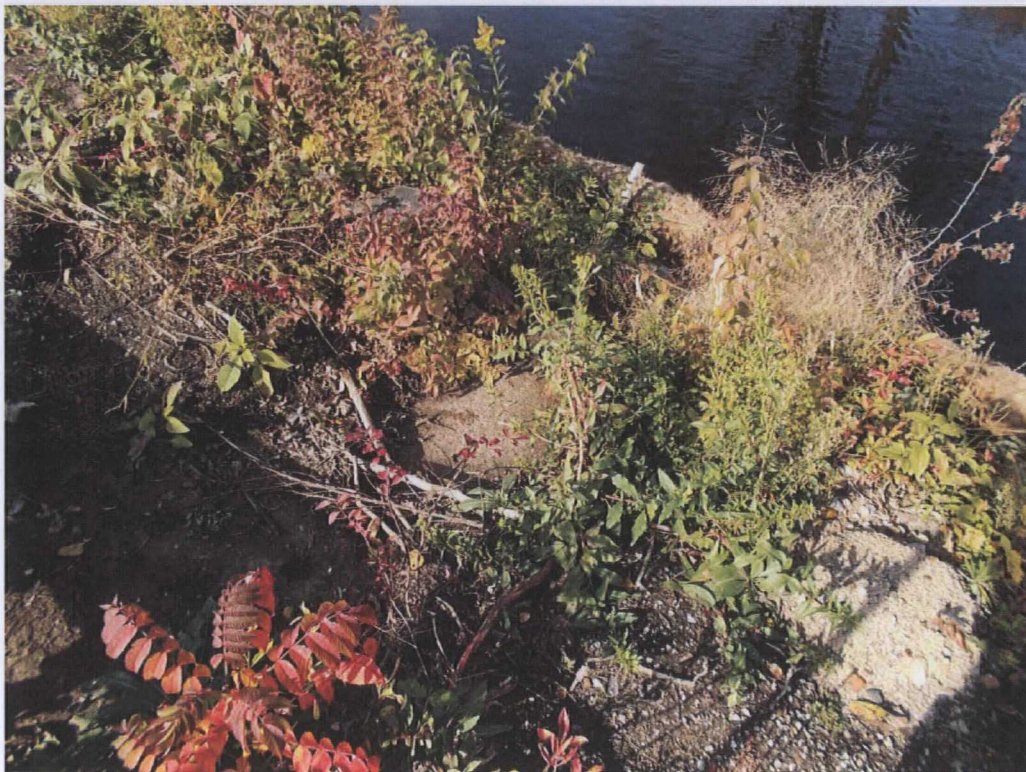
- The lower section of the spillway was removed in conjunction with sediment removal.
- The upper section does not appear to have been impacted during sediment removal.

Remaining upper section of the abandoned spillway

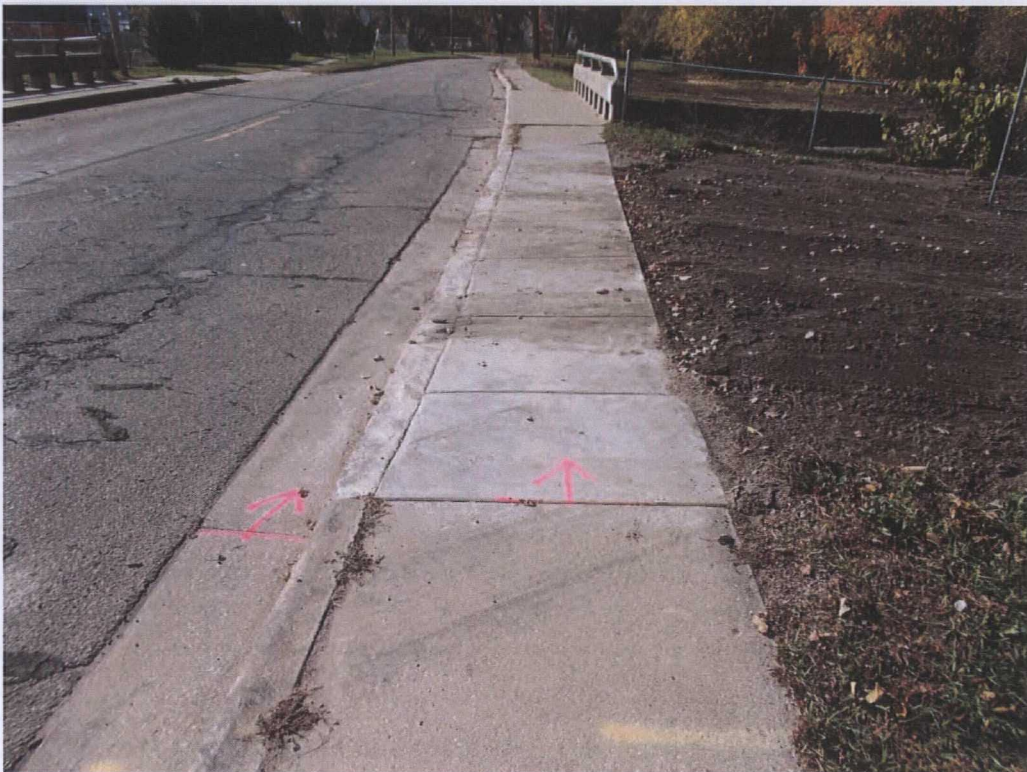
- The curb head was removed in the northeast quadrant to facilitate access. It and the adjacent sidewalk appear to have been marked for replacement.
- Restoration is required in the northwest and northeast quadrants.
- The fence along the northwest block wall should be replaced.
- The structure itself does not appear to have been impacted during sediment removal.

Curb cut in the northeast quadrant

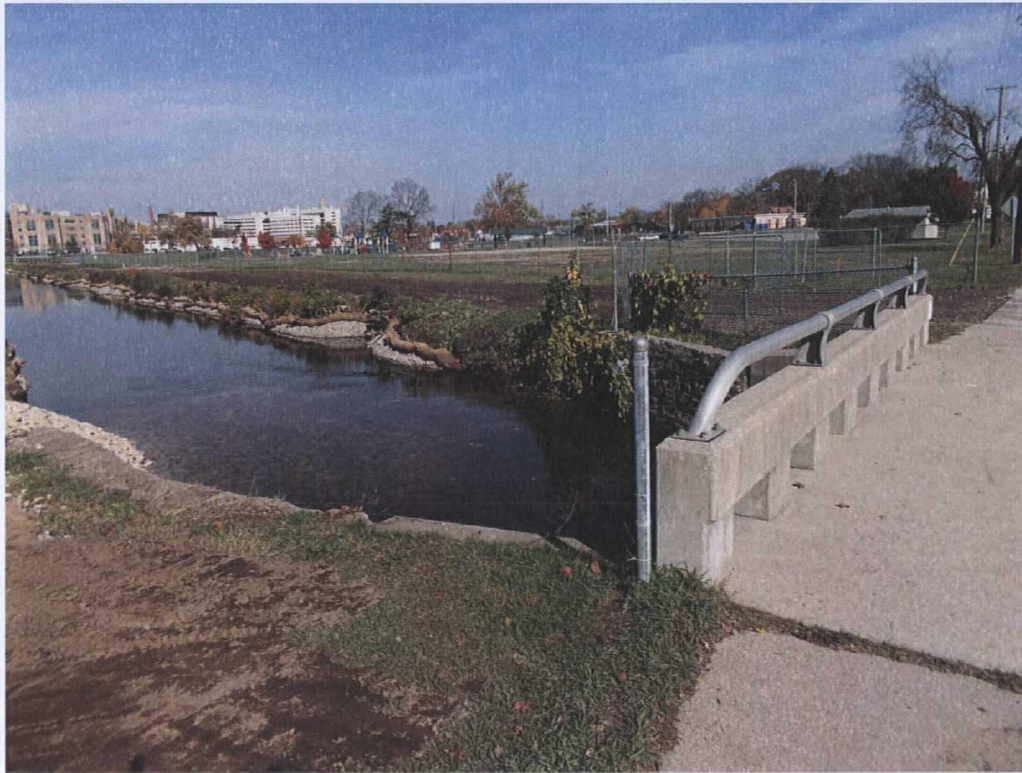
Fence removed in northwest quadrant

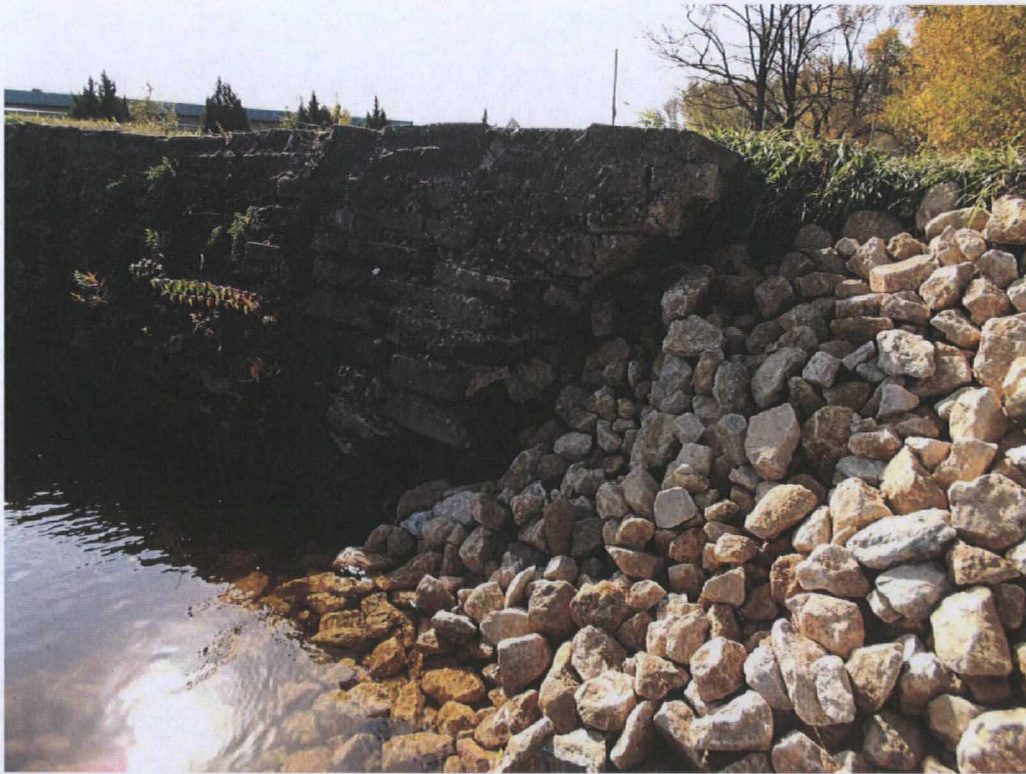
New riprap along northwest block wall

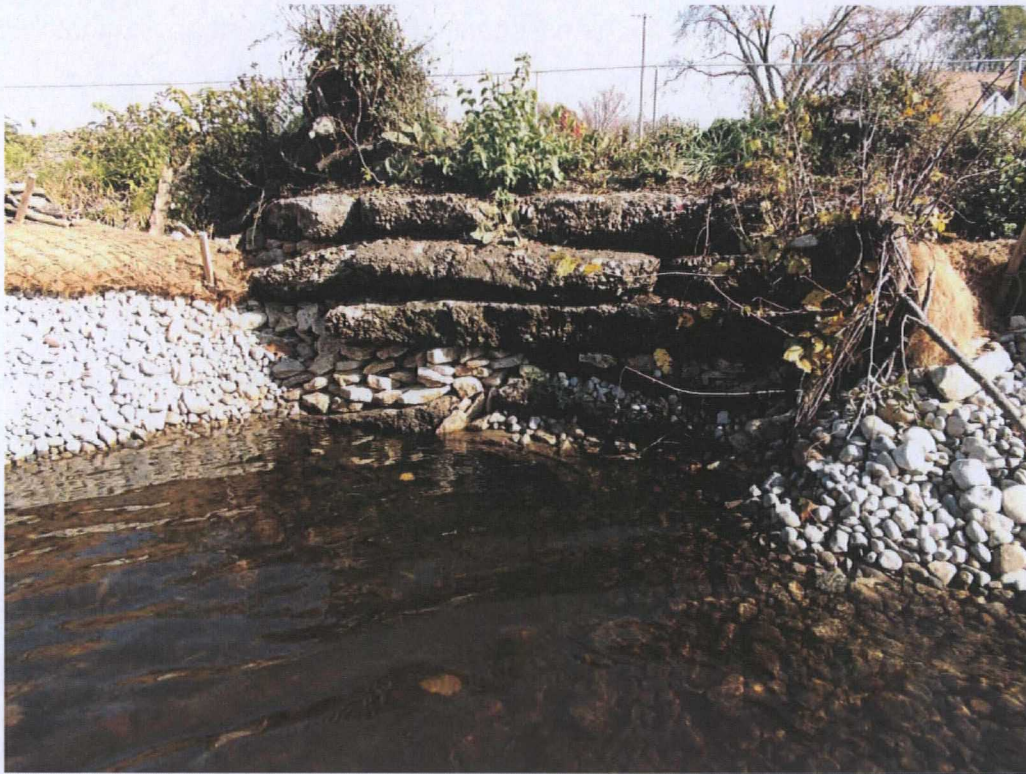
- The rubble wall functions as the headwall for an outlet pipe below the waterline, which was not visible during previous evaluation. Neither the headwall nor pipe appear to have been impacted during sediment removal.
- The bank has been restored around the structure.

View of the structure from the channel

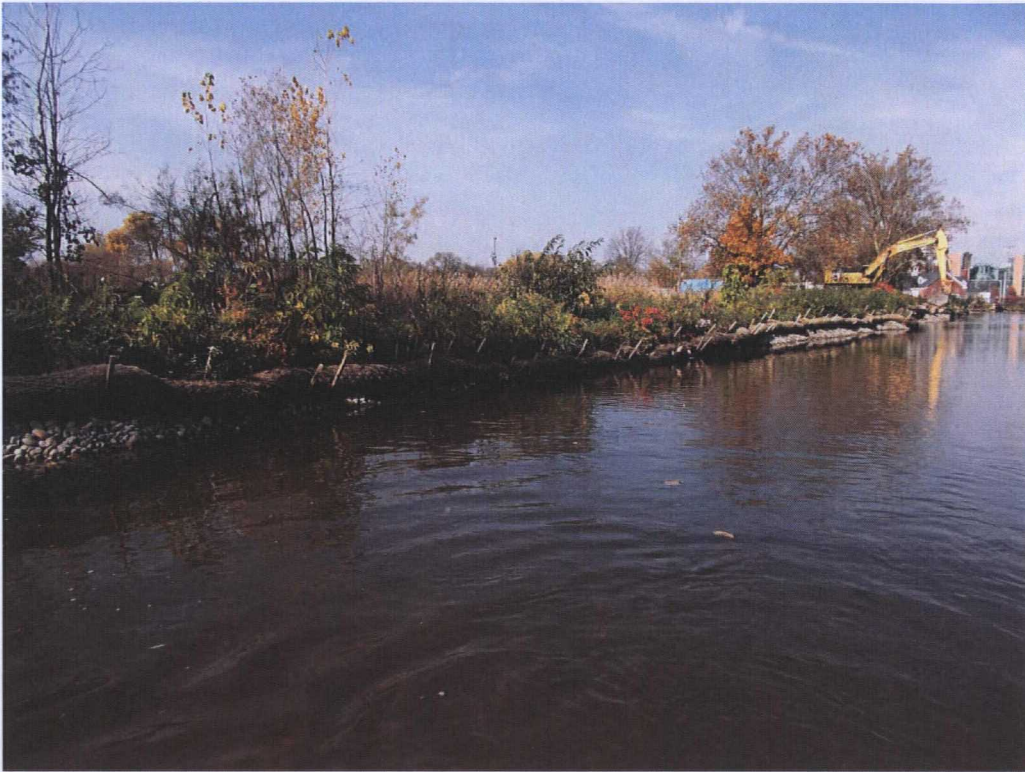
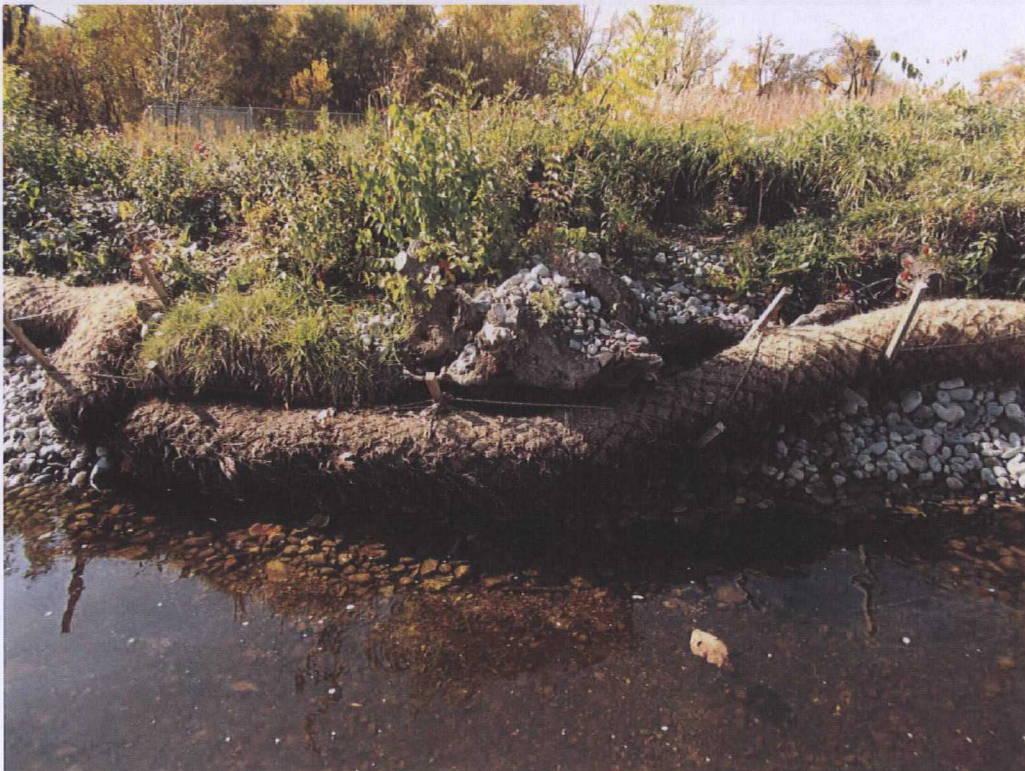
- The concrete wall has been removed. It functioned as a headwall for a clay pipe outlet at the waterline, which was not visible during prior evaluation. The outlet does not appear to have been impacted during sediment removal.

Bank restoration in the previous wall location

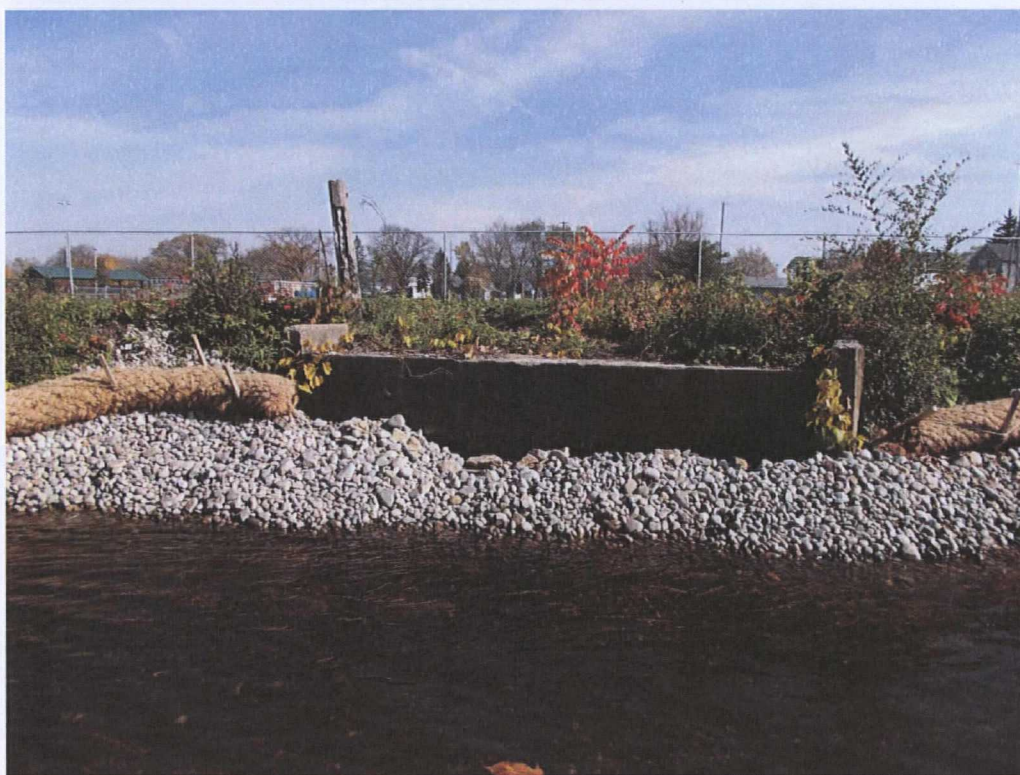
- The structure does not appear to have been impacted during sediment removal. The banks have been restored around the remaining abutments.

View of east abutment from channel area

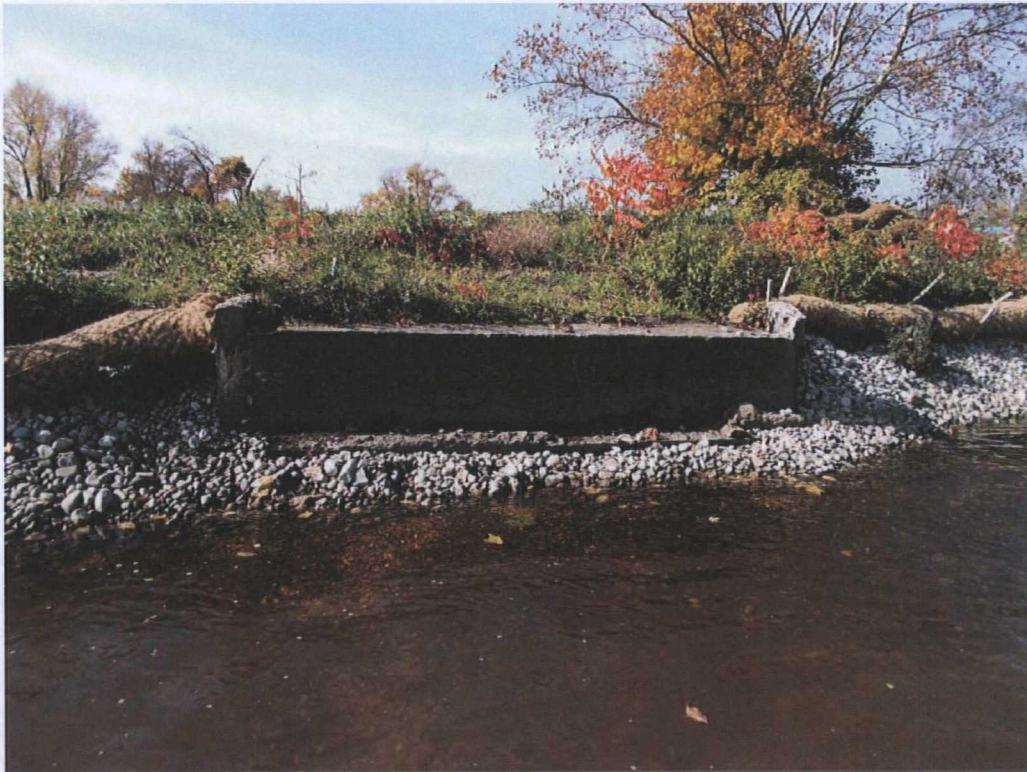
View of west abutment from channel area

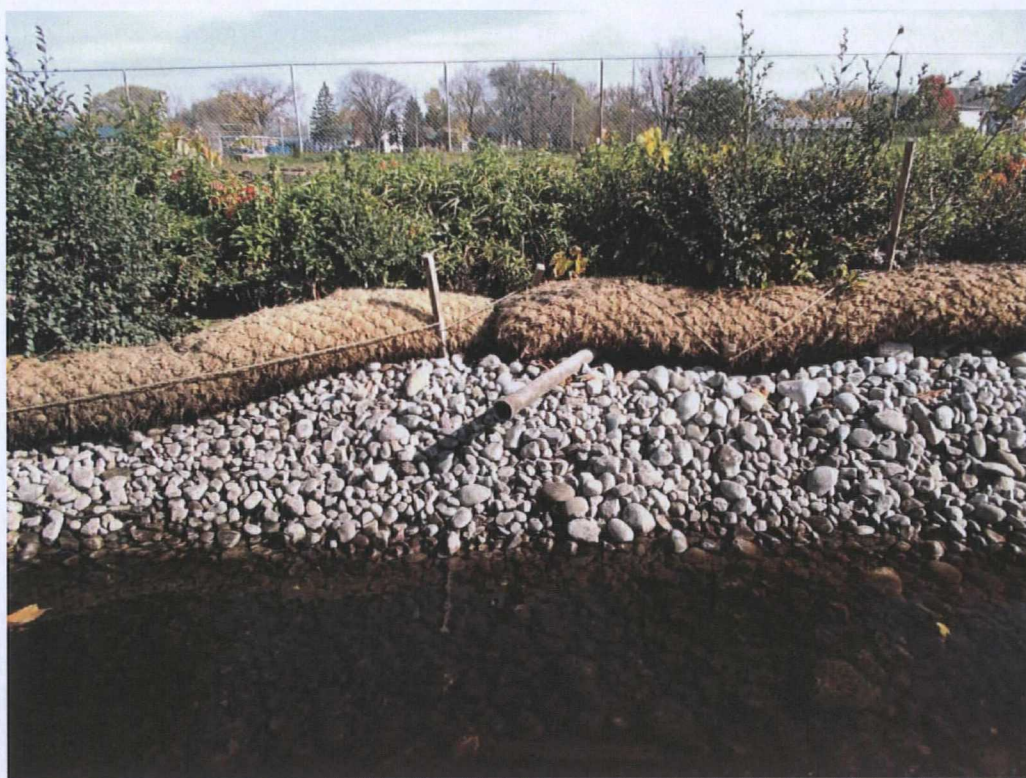
- The structure does not appear to have been impacted during sediment removal.
- The bank has been restored around the structure.

View of the structure from the channel area

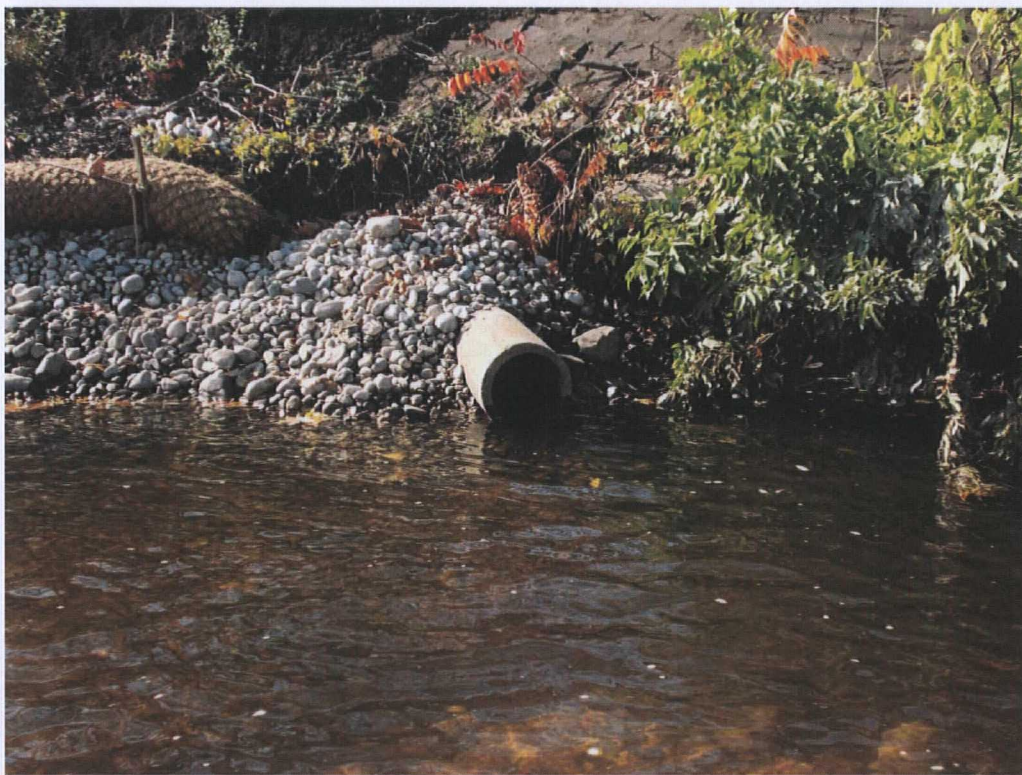
- The failed end section has been removed. The remaining outlet pipe does not appear to have been impacted during sediment removal.

View of the structure from the channel

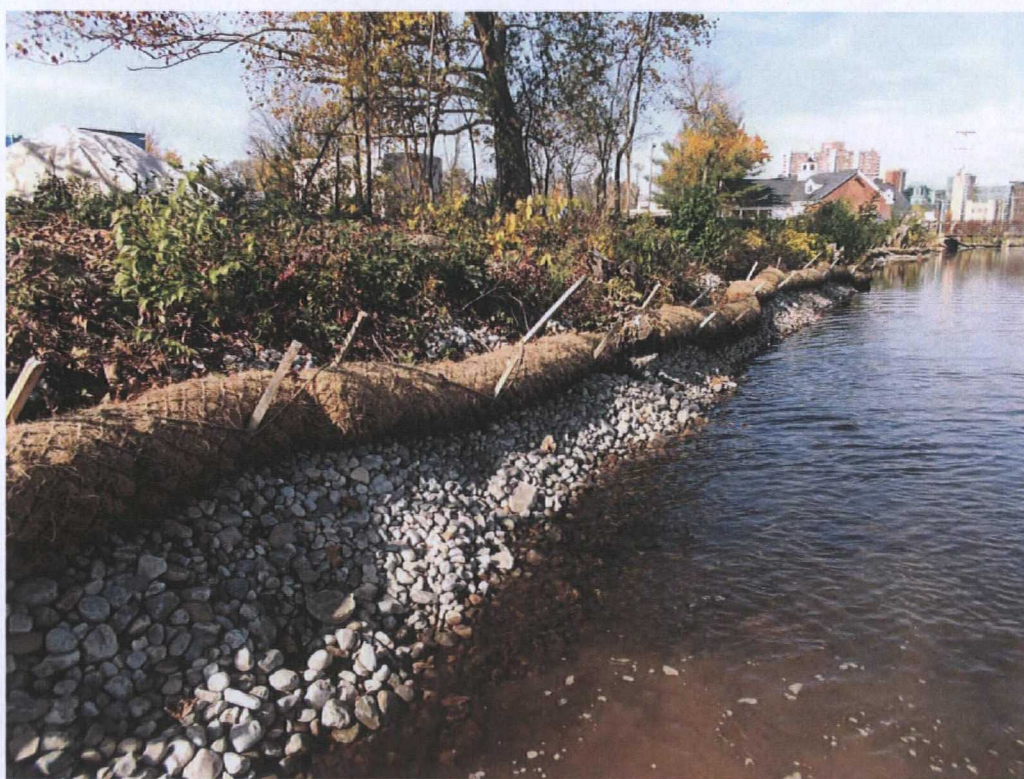
- The structure was removed in conjunction with sediment removal operations.

View of bank restoration along the previous location of the structure
